METER
ENVIRONMENT

COMPRESSION TESTING OF SOIL MOISTURE SENSORS EMBEDDED IN ASPHALT

Brigham Young University

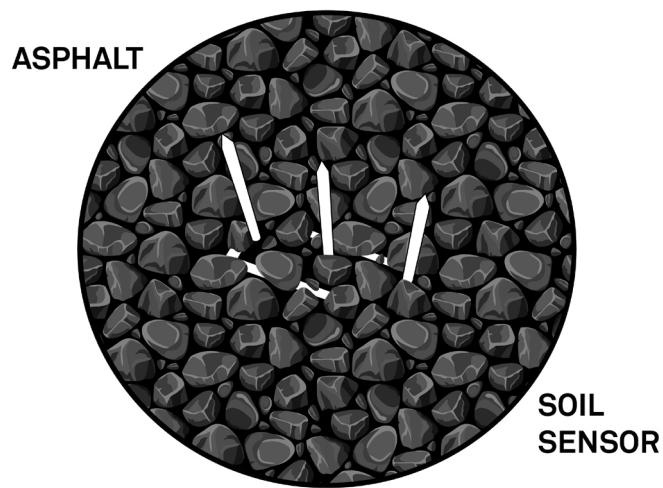
Figure 1. Sensor 1 centered in Sample 1

First, the volume and weight of each sensor were measured. Then the samples were compacted using a modified Proctor hammer. In Sample 1 the sensor was oriented with the prongs vertical as shown in Figure 1, while in Sample 2 the sensor was oriented with the prongs horizontal as shown in Figure 2.

In each sample, the sensor was centered vertically and horizontally within the compaction mold. Both samples were compacted in six lifts with a total of 115 blows. Because the lifts were not necessarily equal in thickness, as required to accommodate the sensor placement, each lift was not equal in number of blows; instead, an equal number of total blows was applied to both samples. After the sensors were placed in each sample, asphalt was compacted around them until they were completely covered; a minimum of 1 in. of loose asphalt was placed over each sensor prior to compaction. The asphalt was pre-heated to a temperature of 275 °F consistent with typical asphalt production temperatures. After compaction, each sample was labeled and weighed, and the height was measured in four locations to obtain an average height of the sample. The samples were then allowed to cool to room temperature.

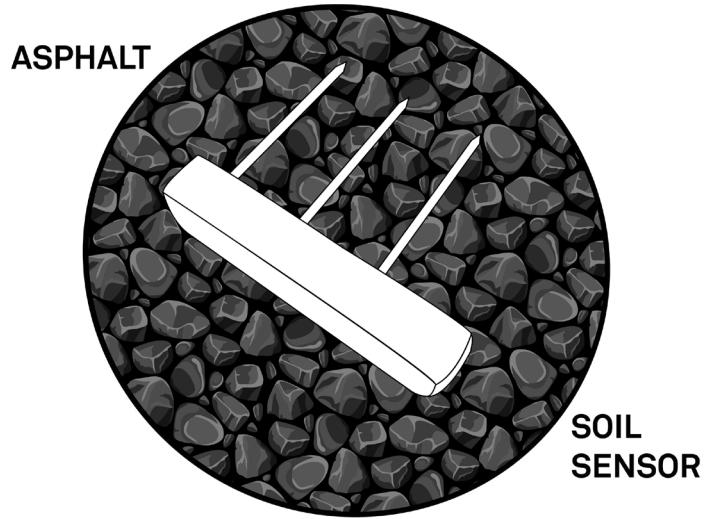
Figure 2. Sensor 2 centered in Sample 2

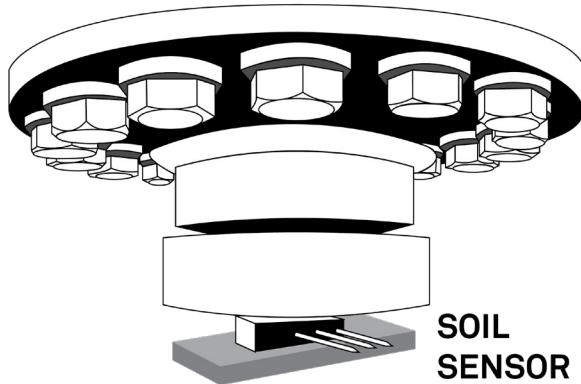
Figure 3. Sensor 1 in compression machine

Several days later, unconfined compression testing was performed on the asphalt samples using a Baldwin compression machine with a floating head. The samples were heated to 140 °F before testing to simulate hot weather conditions typical of Utah pavements. Testing at a temperature of 140 °F is also consistent with the Marshall stability testing protocol. A strain rate of 2 in./min. was used, and load and displacement measurements were recorded throughout testing. The tests were video recorded in order to help determine when the sensors broke. During testing, however, the sensors did not break before the asphalt samples themselves began to fail. Therefore, the sensors, still intact, were removed from the failed asphalt samples and tested separately in the original configurations. Figures 3 and 4 depict the test setups for the vertical and horizontal configurations, respectively.

For testing in the vertical position, Sensor 1 was positioned on a grooved metal plate that held the sensor in the desired orientation. A strain rate of 0.1 in./min. was used for this testing, and the tests were again video recorded.

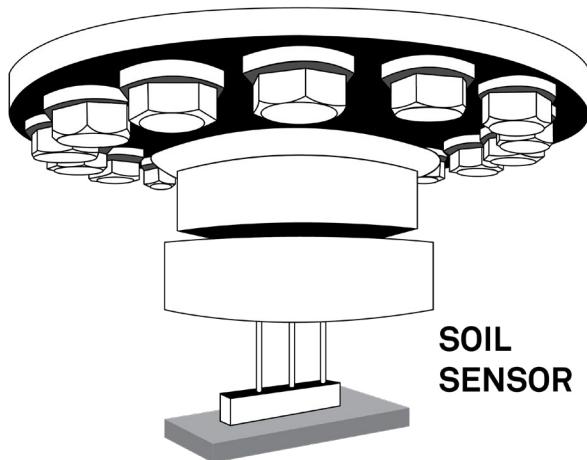
Figure 4. Sensor 2 in compression machine

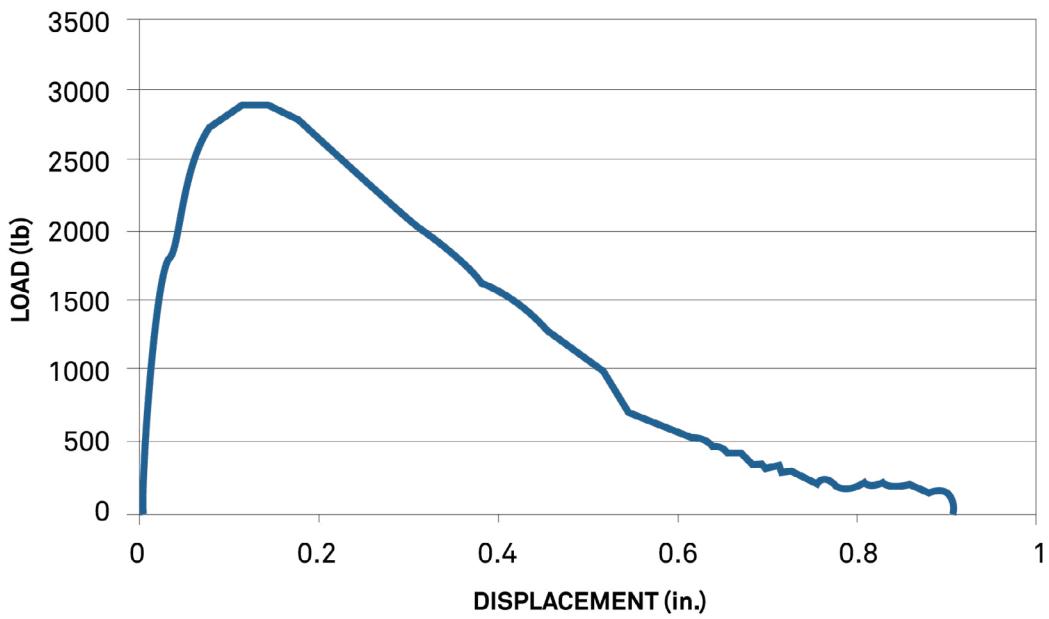
Figure 5. Load-displacement plot for Sample 1 (vertical orientation)

The load-displacement plots for asphalt samples 1 and 2 are shown in Figures 5 and 6, respectively. Sample 1, in which the sensor was vertically oriented, sustained a

load of about 2900 lb, which is more than three times higher than the load of 850 lb sustained by Sample 2, in which the sensor was horizontally oriented.

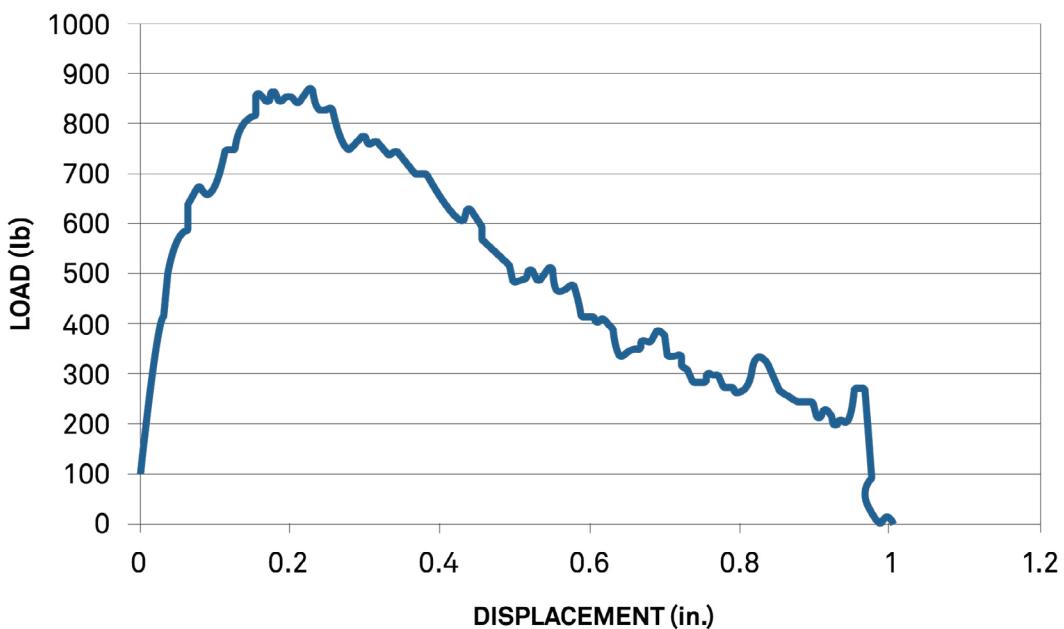
Figure 6. Load – displacement plot for Sample 2 (horizontal orientation)

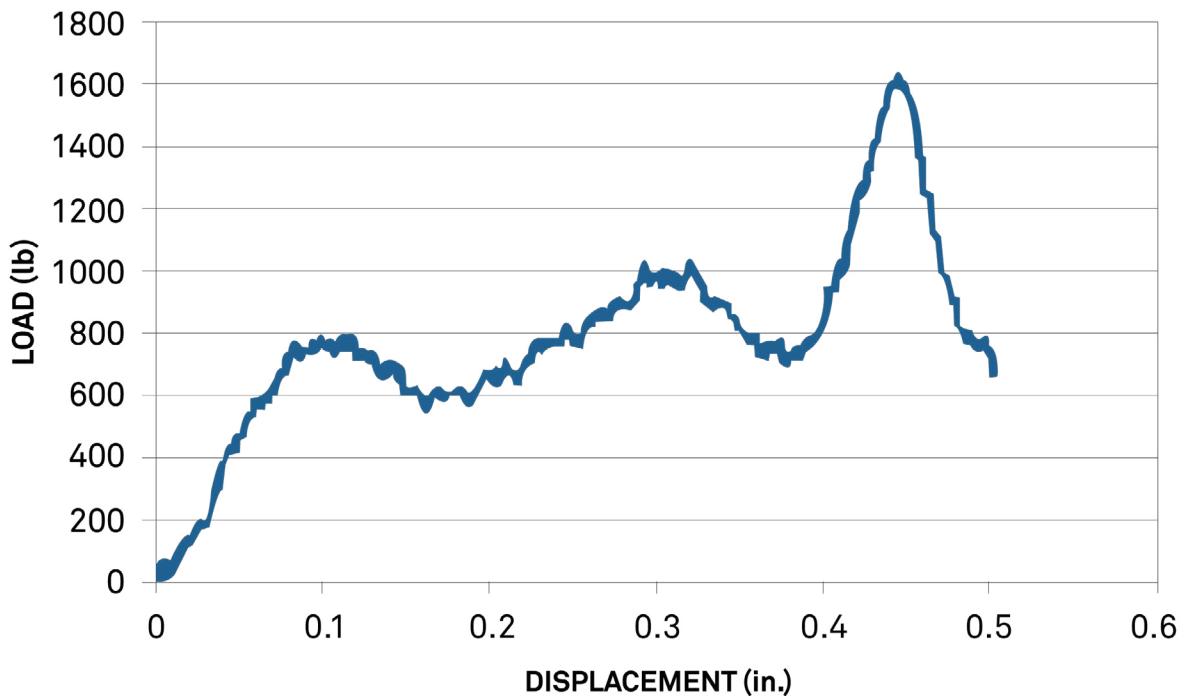
Figure 7. Load – displacement plot for Sensor 1 (vertical orientation)

When tested individually, the sensors performed very differently than the asphalt samples. For Sensor 1, which was oriented vertically, three peaks were observed as shown in Figure 7. The first peak occurred at about 750 lb when the internal structure of the sensor failed under load. The second peak occurred at about 950 lb when the ends of the prongs within the sensor body penetrated the epoxy potting and outer casing, slightly protruding into the groove beneath the sensor body. The third peak occurred at about 1600 lb when the prongs began to bend, as illustrated in Figure 8. The first peak, which would be expected to cause failure of the electronics, is approximately one-fourth of the peak load measured for the same sensor configuration when the sensor was embedded in asphalt. The difference is attributable to the concentration of the full load on the prongs when the sensor was tested by itself.

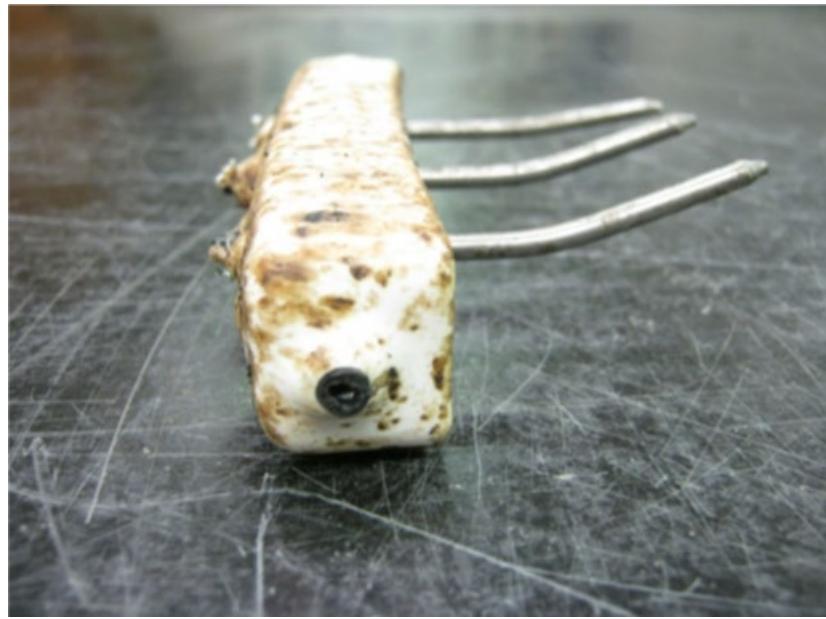
Figure 8. Sensor 1 after compression testing (vertical orientation)

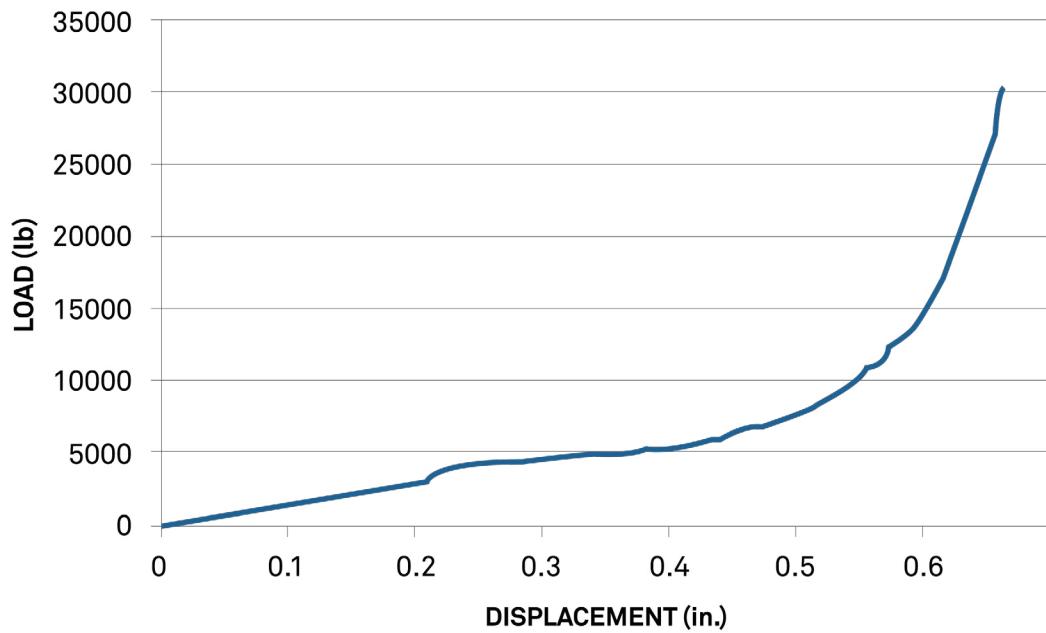
Figure 9. Load-displacement plot for sensor (horizontal orientation)

For Sensor 2, which was oriented horizontally, a continuous increase in load was observed during testing as shown in Figure 9. However, a pronounced change in slope occurred at a load of approximately 3000 lb, which probably resulted from the crushing of the internal components and would therefore be expected to cause failure of the electronics. The sensor began to separate from its outer casing at a load of about 6500 lb and was nearly completely separated by the end of the test as shown in Figure 10. The load at which failure of the electronics would be expected is more than three times greater than the load measured for the same sensor configuration when the sensor was embedded in asphalt. In this case, the difference is attributable to the fact that the strength of the sensor body exceeds that of the apparent strength of the asphalt.

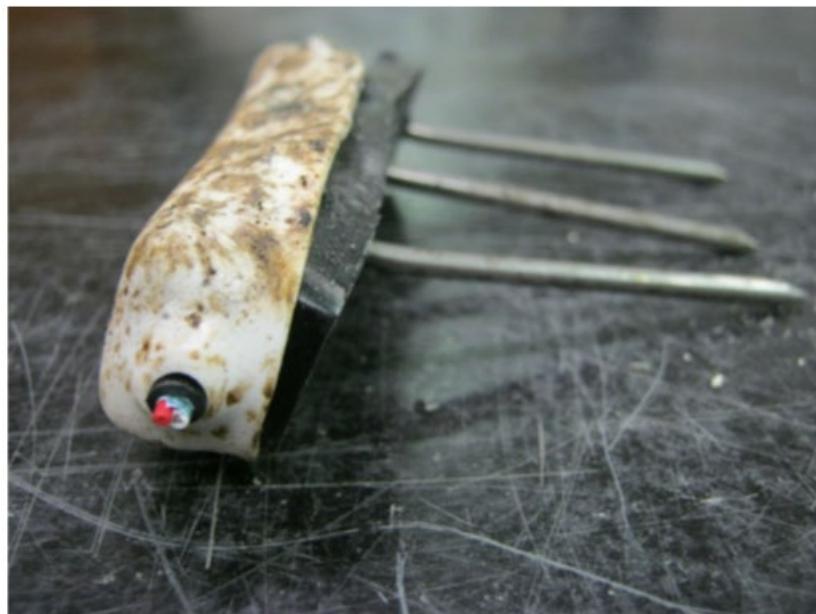
Figure 10. Sensor 2 after compression testing (horizontal orientation)
